NELLHI

New all-European high-performance stack: design for mass production

Deliverable 4.4

Summary of steel pre-coating materials, characterization and coating and manufacturing process

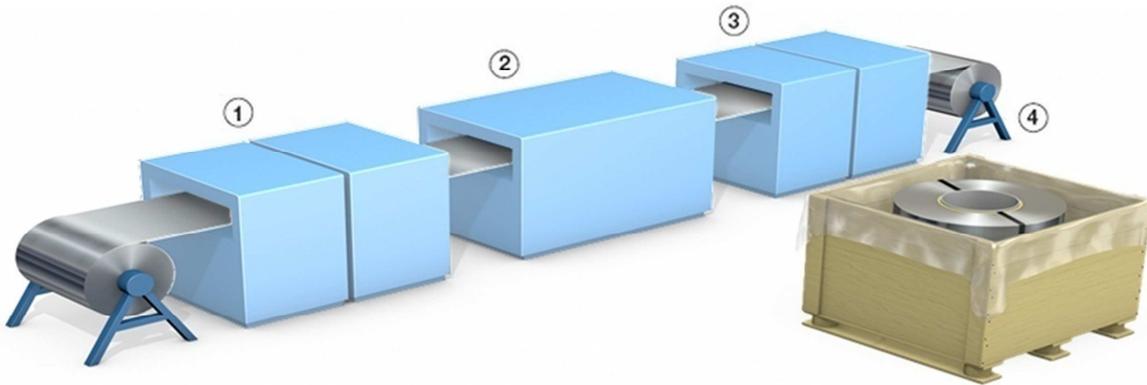
Figure 2. Schematic overview of the pre-coated strip production at Sandvik.

Sandvik's coating technology is environmentally friendly, with no discharge to water or air, and no toxic residues. The coating process is also energy efficient compared to electroplating, which consumes approximately 60% more energy. A schematic overview of the process is displayed in Figure 2. The connection in the project between Sandvik and Borit and the total production route benefits are explained in Figure 3.

Process steps in Sandvik's coating process (Figure 2) are as follows:

1. Cleaning/inspection

Cleaning is important for good adhesion. To avoid harmful defects, the whole area of the strip surface is inspected – both sides.

2. Coating

Coating of metal layers by Sandvik's continuous evaporation coating process.

3. Inspection

Automatic X-ray inspection devices measure the thickness and quality of the coating.

4. Testing, slitting and packaging

After coating, the steel strip is inspected and tested (for example tensile, hardness and surface properties). The process is completed by slitting to the required width, control of burr height, width and shape, and finally by packaging and shipment.

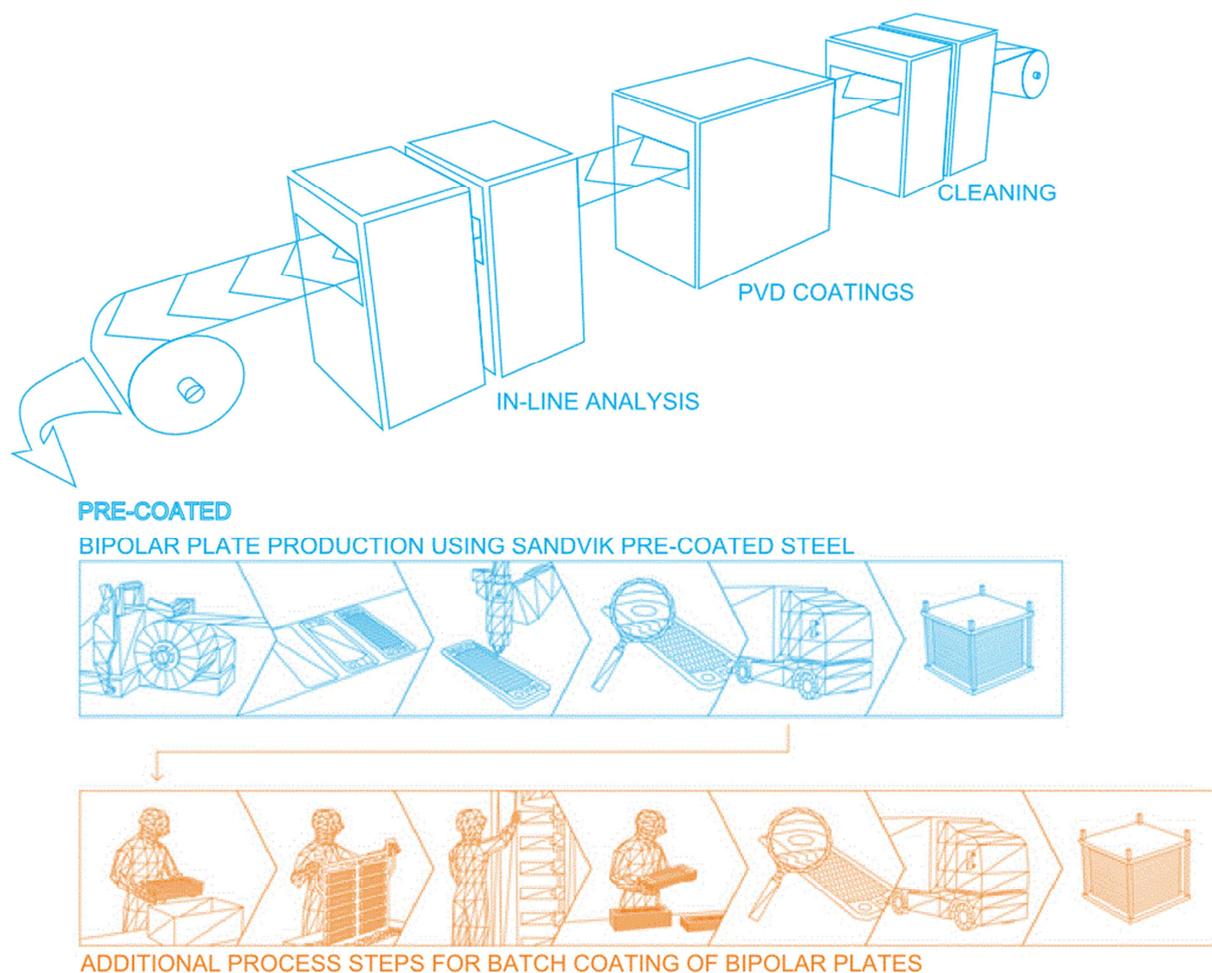
Figure 3. Blue route: The steel coil is first cleaned, then coated in one or multiple steps, analyzed and then shipped for shaping at Borit. The Sandvik coil-coating concept together with Borit’s hydroforming enables an industrial interconnect production process that shortens the entire value chain by eliminating the costly need of coating of individual plates i.e. the additional process steps (in orange above). The principal difference in manufacturing flows from raw material coil to final fuel cell stack can be described as in the illustration above.

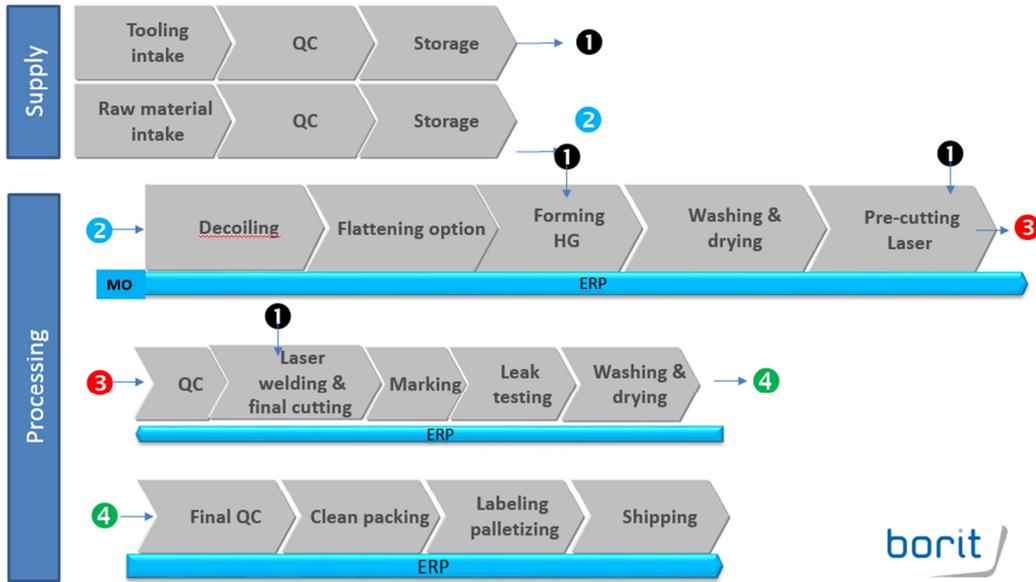
Figure 4. Process flow for production of welded bipolar plates

Based on the experiences gained in the project, the process flow to produce welded bipolar plates for fuel cells at Borit is presented below in Figure 4.

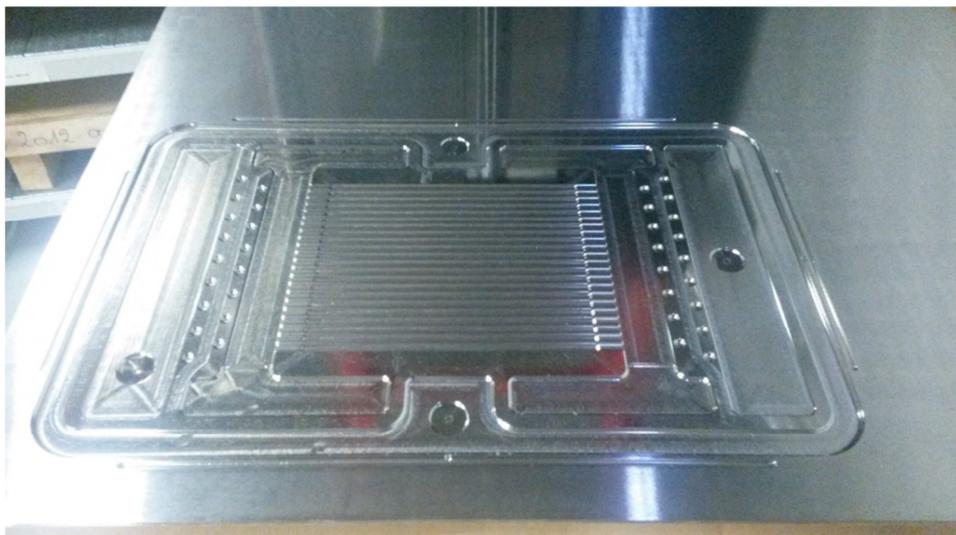
Figure 5. Die for hydroforming interconnects

Using the proprietary forming process called *Hydrogate*, the individual parts are formed using a forming tool as shown below. The inherent gentle nature of the hydroforming process guarantees good compatibility with coated (and uncoated) raw materials.

The forming pressure used in the *Hydrogate* process is 1750 bar. After laser cutting, where a dedicated cutting tool is used, 2 parts with an additional insert have been welded together. A dedicated laser welding tool and set-up has been manufactured in order to enable welding of the separate plates. After welding, all interconnects are leak tested to ensure the quality of the welded contour. Due to some height differences in the sealing contour, the standard leak test is not possible. The plates have been leak tested using a bubble test.

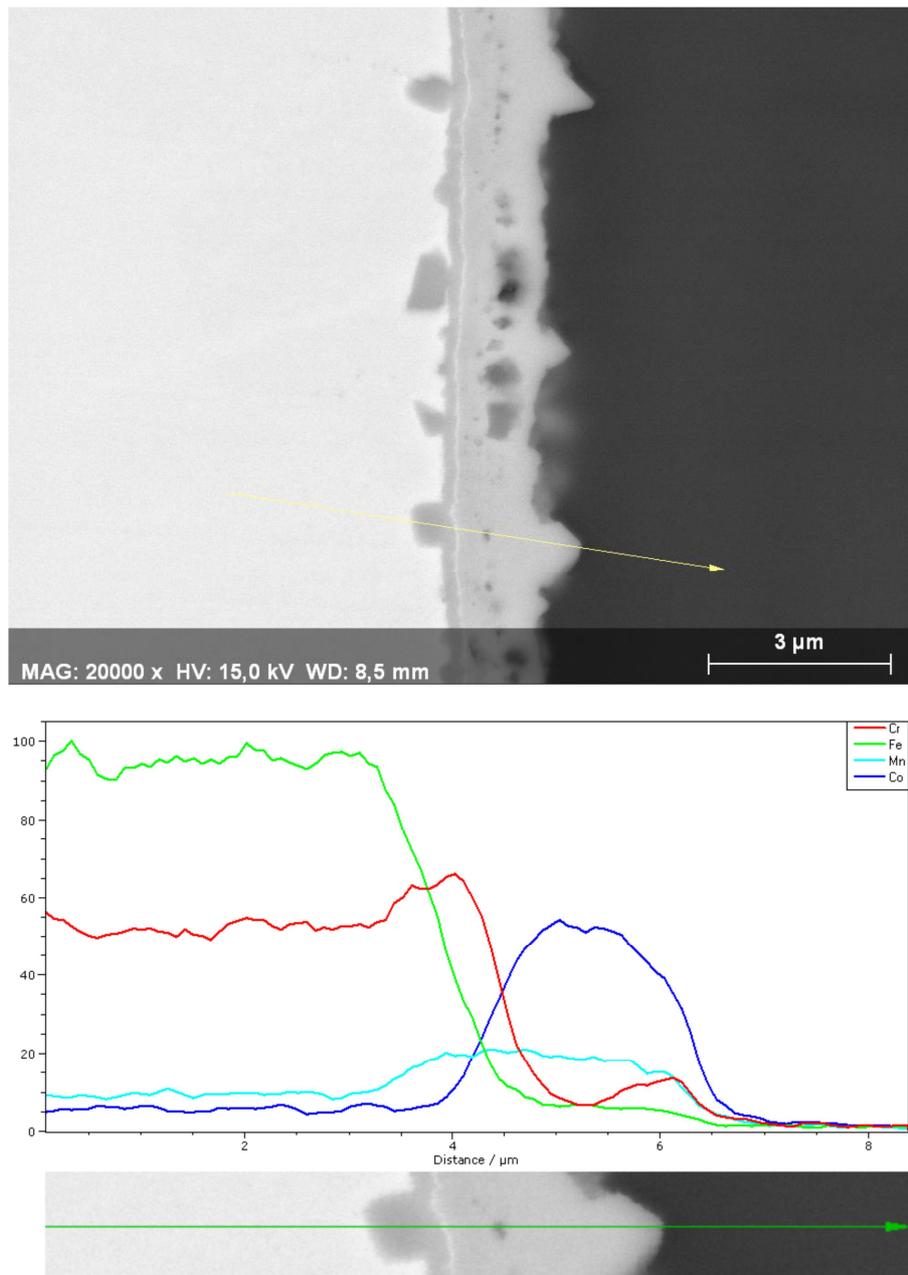
Figure 6. SEM picture and EDS linescan of coated Crofer 22 APU after 1000 h of exposure at 700 °C in dry air.

After 1000 h of exposure, in most of the samples no Cr diffusion to the coating was seen which indicates that coating is working as wanted. Only in second test with Crofer 22 APU samples there was some Cr diffusion as there was Cr-rich crystals detected in the surface of the samples after 1000 h (**Figure 6**). Also, in the first 1000 h test with Crofer 22 APU samples, significant Fe diffusion from steel to coating was seen as after exposure the top layer of the coating was CoFe-spinel. In the second 1000 h test Fe-diffusion was no more detected which could be due to better sample treatment.

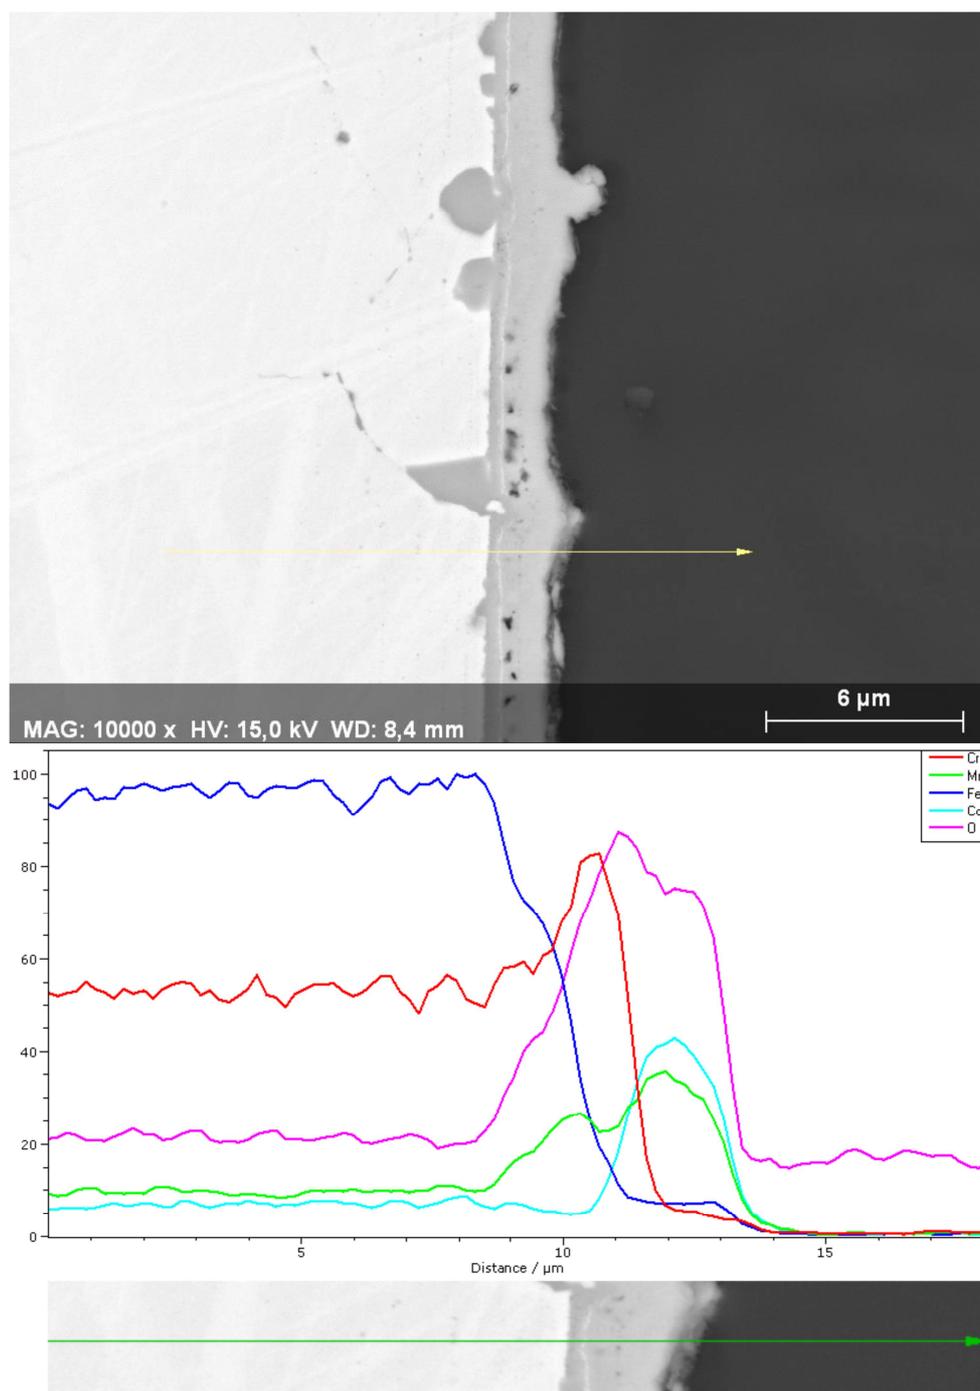
Figure 7. SEM picture and EDS linescan of Co/Ce-coated Crofer 22 APU after 5000 h of exposure at 700 °C in dry air.

The results from the longer 5000 h test were in line with the shorter tests. Co/Ce-coating prevents the diffusion of chromium effectively. Only in the case of Crofer 22 APU some local chromium diffusion was detected. Also, no Fe-diffusion was seen with Crofer 22 APU in the 5000 h test as can be seen in **Figure** . Amount of manganese in the coatings continued to increase as exposure time increased as suspected. After 5000 h Mn/Co-ratios in the coating were 1/7 with AISI441, 1/4 with Outokumpu 4622 and close to 1/2 with Crofer 22 APU. Thus, in the Crofer 22 APU samples compositions would already be that of MnCo-spinel.

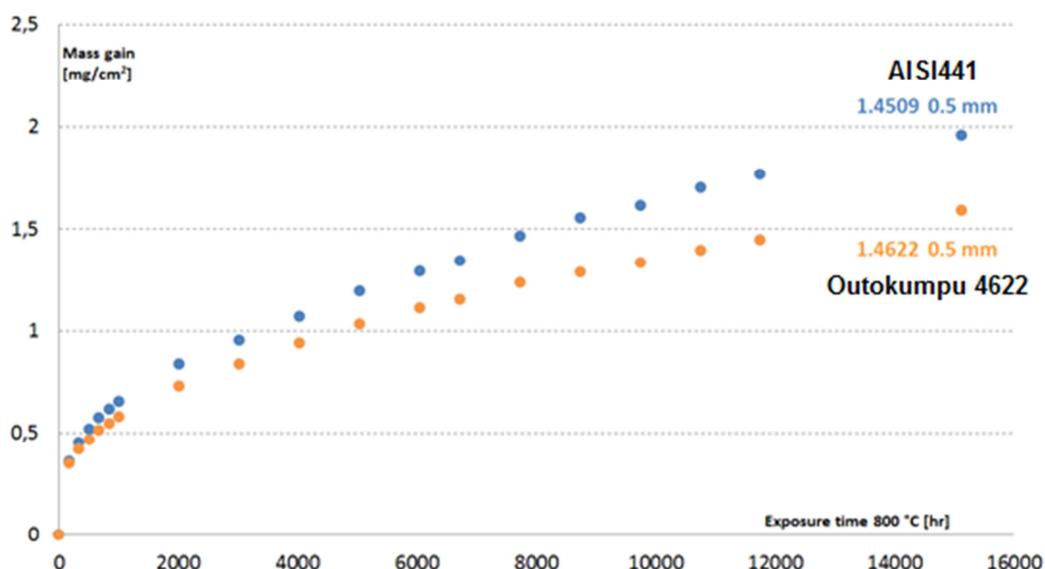
Figure 8. Cyclic oxidation of Ce 10 nm/Co 600 nm pre-coated 0.5mm stainless steels at 800°C in ambient air.

Cyclic oxidation for more than 15,000 hours of pre-coated AISI441 (EN 1.4509) and Outokumpu 4622 (EN 1.4622) at 800°C is displayed in Figure 8. Coupons of the materials exposed and the mass gain is measured by weighing of the coupons at different exposure times. In Figure 9 cross sections of selected samples were examined by light microscopy and scanning electron microscopy with energy dispersive spectroscopy (SEM+EDS) to understand if long term exposure of the steels changes the microstructure as well as the coating. The micrographs in Figure 9 show grain growth of Outokumpu 4622 with increased exposure time, which is not seen in AISI441 (1.4509). In SOFC applications lifetime of the stack of beyond 40,000 hours is desired and the grain growth seen in Outokumpu 4622 is a problem for long term exposures.

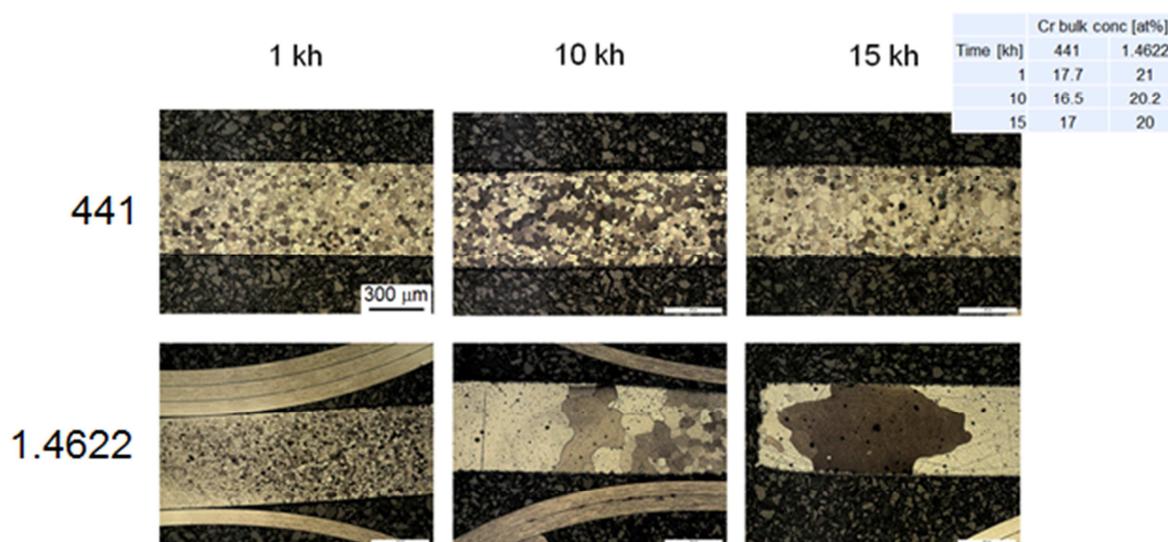
Figure 9. Cross sections examined by light microscopy of precoated stainless steels exposed to cyclic oxidation at 800°C in ambient air. The different exposure times of 1000, 10,000 and 15,000 hours show grain growth of Outokumpu 4622 with increased exposure time, which is not seen in AISI441. The chromium (Cr) bulk concentration is measured by SEM EDS.

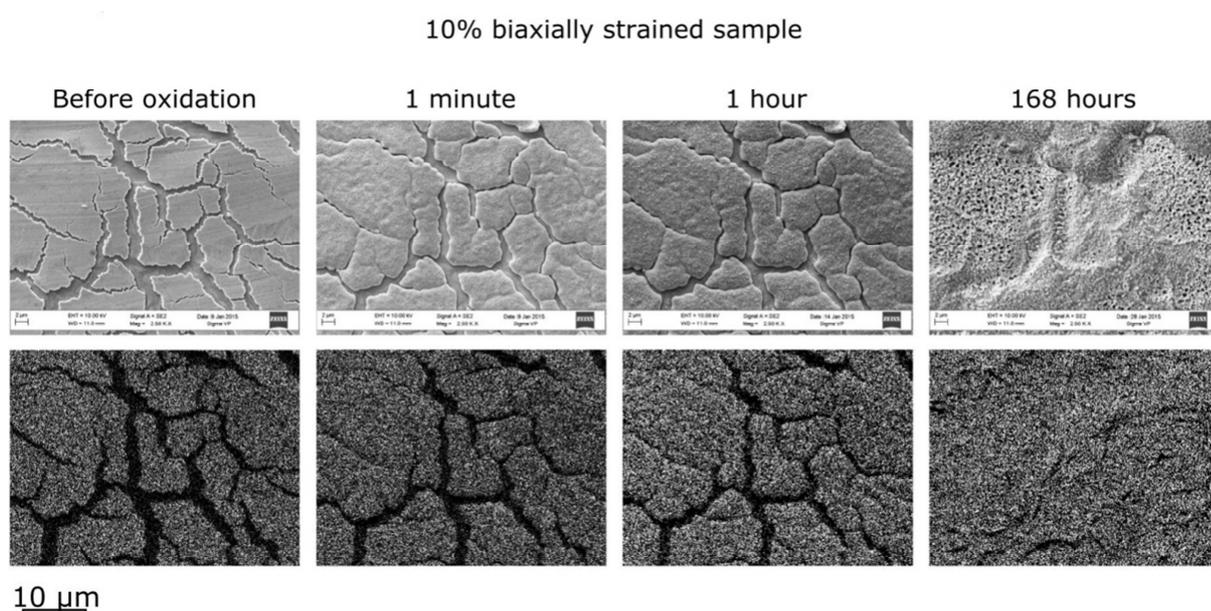
Figure 10. SEM images of strained and oxidized (800 °C) samples (top), EDS cobalt maps from corresponding areas (bottom).

The strained sample was examined in a scanning electron microscope (SEM). It was seen that the coating had cracked during the forming operation. Parts of the cracked surface can be seen in Figure 10 in the upper left image. None of the examined cracks on the sample exceeded 5 µm in width. This figure can be thought of as an approximate upper limit for the crack width because the sample was strained to the very limit before the steel would rupture. Despite the cracks, no delamination could be observed on the surface, indicating good adhesion between the substrate and the coating.

The cobalt maps shown in Figure , recorded with energy dispersive x-ray spectroscopy (EDS), confirm that no or only very little cobalt was present in the cracks after forming. During the initial oxidation the smallest cracks (< 1 µm) would become enclosed due to the volume expansion of the metallic cobalt coating when

this was oxidized. At 800 °C the oxidation of 600 nm cobalt happens within a couple of minutes. After an hour of oxidation, small (~100 nm) oxide grains protruding from the cobalt coating became evident but no further sealing of the cracks was observed. When the sample had been exposed for 168 hours (one week) at 800 °C the entire sample surface had become clearly oxidized with oxide grains, ranging from a few hundred nanometers to a couple of micrometers. At this stage no traces of the cracks were seen and the EDS map indicated that cobalt was now present over the entire surface.

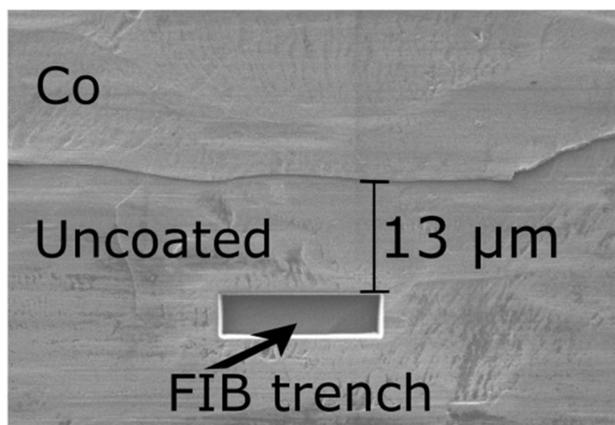
Figure 11. A FIB trench was milled as a reference point close to the edge.

Before coating the sheets, one of the samples was marked with a thin line, drawn with a felt pen. After the coating step the line (and the coating on top of it) was removed using an ethanol soaked cotton q-tip. This would create a well-defined stripe where no coating was present on the surface. In this uncoated region a trench was milled at a set distance (13 μm) away from the coated border using a focused ion beam (FIB), see Figure 11. This trench could then be used as a reference point during oxidation trials.

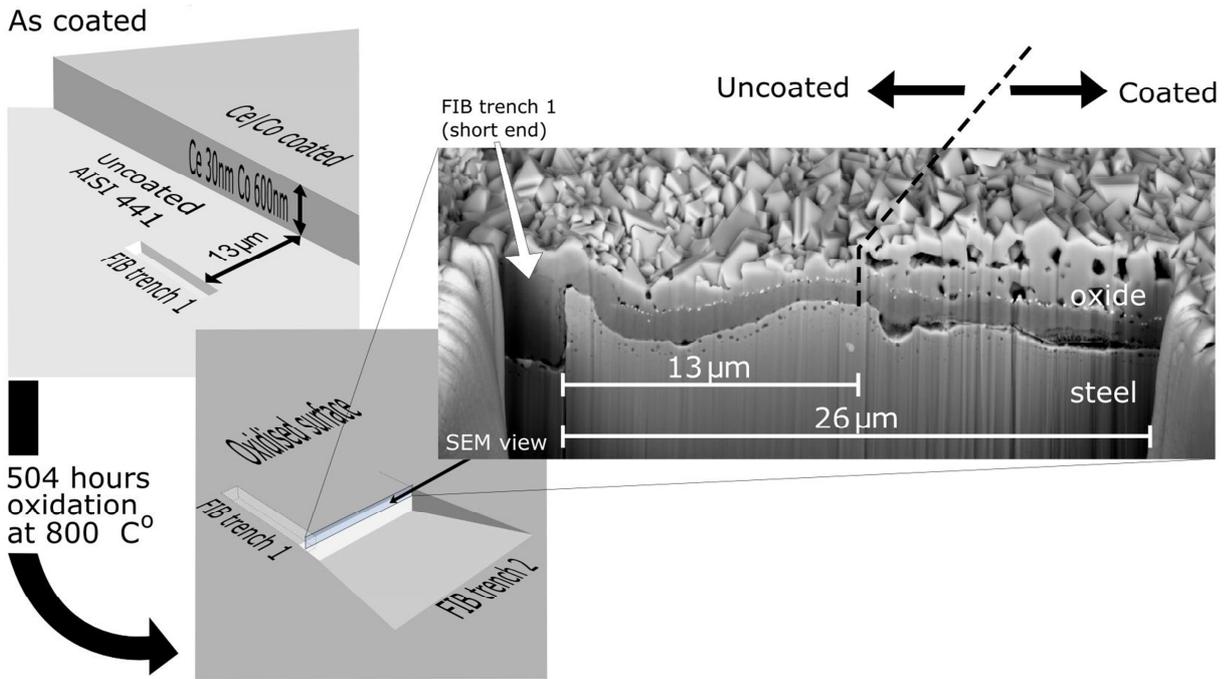
Figure 12. The AISI441 sample was masked before being coated with 30 nm cerium and 600 nm cobalt, respectively. With the mask removed a sharp border between coated and uncoated surface was created. After oxidation at 800 °C the formed oxide of the uncoated part was examined. Cerium rich particles were detected in the scale as far as 10 μm away from the coated area.

When stretching the coated steel in the deep drawing cup test or in a tensile test rig cracks were generated in the coating up to 5 μm wide. After that point the steel would fracture. The masking approach described above was therefore used to produce larger areas without any coating. The masked sample with the FIB trench milled into it was oxidized and examined in the SEM. After 504 hours (three weeks) of oxidation at 800 °C a second FIB trench was milled at a right angle towards the first trench. This second trench, which was about 26 μm wide, stretched from one of the short ends of the first trench and roughly 13 μm into the coated part of the steel, shown in Figure .

The second trench therefore showed both the previously uncoated area and the coated part of the sample. Interestingly the oxide formation of the two had much resemblance. As commonly seen for these cobalt coated steels the upper oxide scale was dominated by two fairly distinct layers. These have been shown to consist of an upper spinel type oxide and beneath a chromia layer [3].

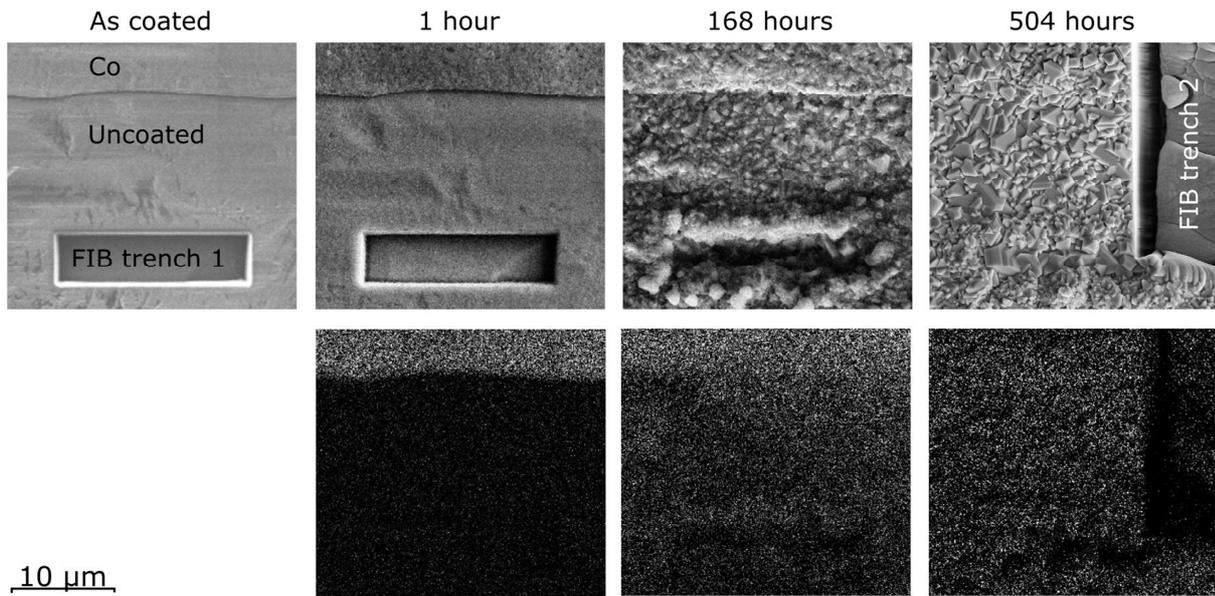
Figure 13. Top row shows SEM images of the investigated area before and after 1 hour, 168 hours and 504 hours of oxidation at 800 °C. The bottom row shows cobalt EDS maps of the oxidized samples.

In Figure 13 the progression of the cobalt diffusion is shown by EDS maps collected at different exposure times. As discussed earlier, when stretching the coated steel in the deep drawing cup test or in a tensile test rig the cracks generated in the coating had widths up to 5 μm. This demonstrates how diffusion from one side of a crack would progress. However, in a real application the cobalt would diffuse from both sides of the crack on the sample surface. Consequently, cracks up to 25 μm could be self-healed based on the cross-sections in Figure 13 given enough exposure time and temperature is supplied.

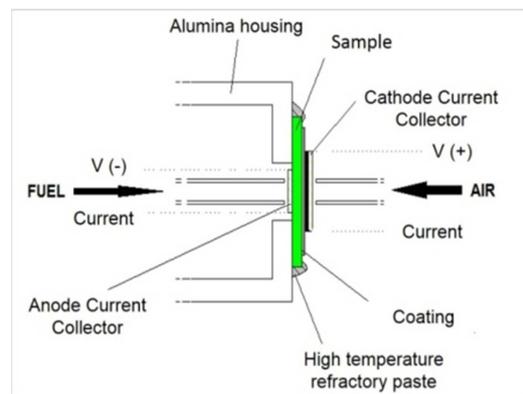
Figure 14. Schematic representation of the single cell system used for the dual-atmosphere oxidation tests.

Dual-atmosphere oxidation tests were conducted at 650 °C up to 1000 h at ENEA CR Casaccia premises. Uncoated Crofer 22 APU samples from a thin foil (0.2 mm thickness) were cut to a round shape (20 mm diameter) and mounted into a conventional single fuel cell test system, which allowed a continuous monitoring of contact resistance during the dual-atmosphere oxidation exposure (Figure 14). Humid air was fed at the air-side of the steel sample at 100 ml/min, while fuel gas was fed at the opposite side of the steel sample at a rate of 25 ml/min. Two different fuel gas compositions were used for these tests:

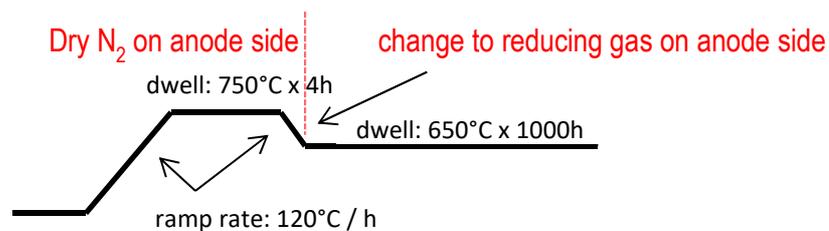
Figure 15. Temperature profile program for the dual-atmosphere single cell tests.

The temperature profile chosen for conducting the experiments is illustrated in Figure 15. During heating up of the cell, the anode side of the cell was fed with dry nitrogen flowing at 25 ml/min. Change to fuel gas was done at the beginning of the dwell 650 °C segment. Contact resistance between the sample surfaces and gold current collectors was measured every 24 h and reported in terms of Area Specific resistance (ASR) by using Electrochemical Impedance Spectroscopy (EIS). The impedance at high frequency was used to estimate the ASR values. No duplicate exposure tests were performed. Post-mortem analysis was performed with SEM/EDS and X-Ray Diffraction (XRD) analysis.

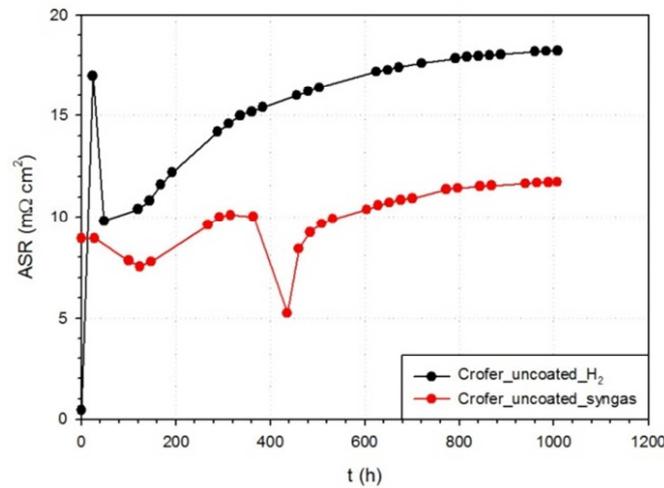
Figure 16. Evolution of ASR contract resistance values during dual-atmosphere oxidation in single cell tests.

Figure 16 reports the ASR contact resistance results. It is seen that contact resistance evolves gradually in both the cases, although higher resistances are obtained when humid hydrogen was chosen as fuel gas. No breakaway corrosion degradation features are observable from the ASR values.

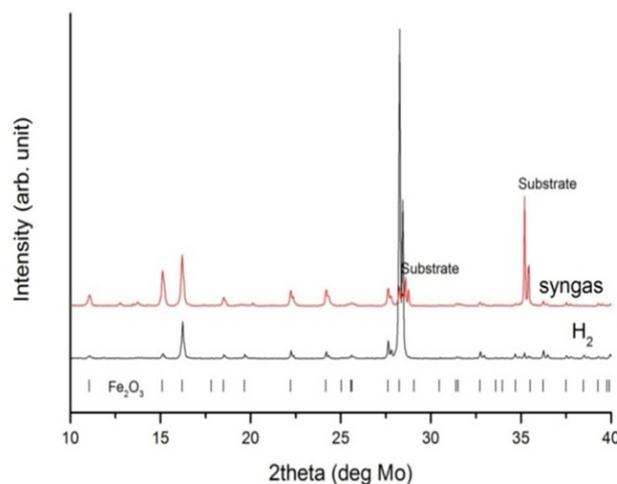
Figure 17. XRD spectra of uncoated Crofer 22 APU after 1000h exposure at 650 °C in dual-atmosphere oxidation conditions using syngas and humid hydrogen as fuel gases

XRD spectra of the air-side surface of samples after 1000h exposure at 650°C is illustrated in Figure 17. Hematite is the main phase present in both the cases. However, substrate signal is detected only in the case of syngas fuel gas suggesting that thickness of the hematite layer is much higher when humid hydrogen is used as fuel gas.

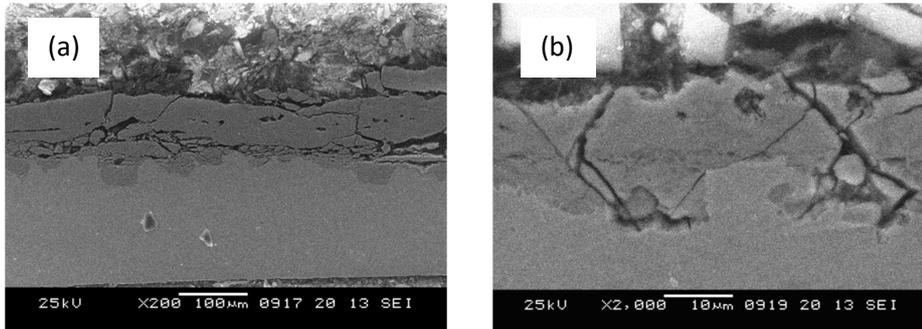
Figure 18. Metallographic cross-section of uncoated Crofer 22 APU after 1000 h exposure at 650 °C with two different fuel gases: (a) humid hydrogen; (b) syngas

Metallographic cross-sections of the oxide scale grown on the air side of the Crofer 22 APU samples (Figure 18) were in line with the XRD results indicating the formation of a continuous hematite layer with a thickness of about 50-60 μm when the anode side was exposed to humid hydrogen and 10-15 μm when exposed to syngas.

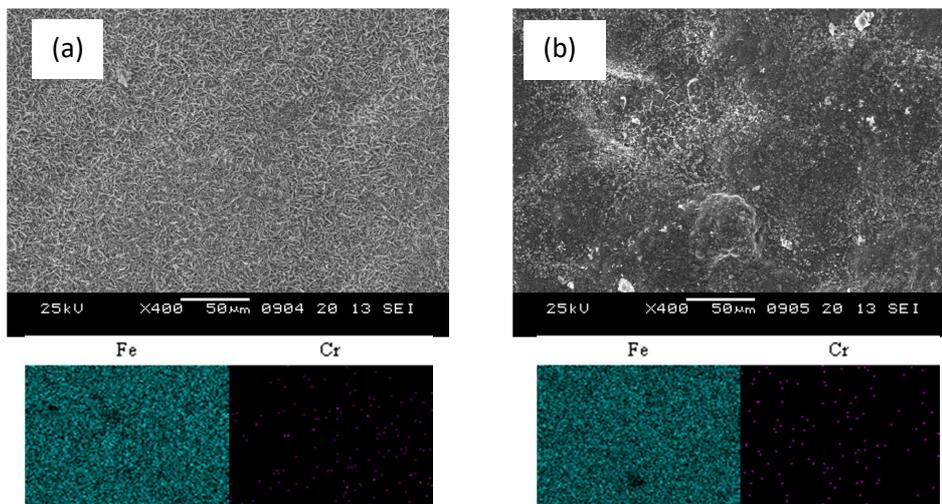
Figure 19. Surface morphology of the air-side oxide scale of uncoated Crofer 22 APU after 1000 h exposure at 650 °C with two different fuel gases: (a) humid hydrogen; (b) syngas

The surface morphology along with EDS mapping of Fe and Cr elements of the air-side oxide scale is seen in Figure 19. A more porous and apparently less protective oxide structure is visible in the case of humid hydrogen as fuel gas. Element mapping clearly indicates that Fe covers homogeneously the entire surface in both the cases with no distinct differences in the surface composition of the oxide scale.

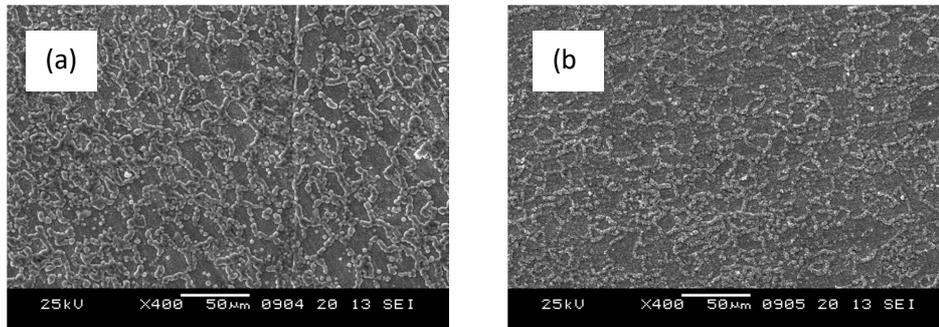
Figure 20. *Surface morphology of the fuel-side oxide scale of uncoated Crofer 22 APU after 1000 h exposure at 650 °C with two different fuel gases: (a) humid hydrogen; (b) syngas*

Figure 20 shows that no significant differences can be observed in the morphology of the fuel-side surface after testing. In both the cases, the surface appears decorated by lines of oxide particles grown along the grain boundaries of the steel. The oxide particles are essentially formed of Cr,Mn-oxides (presumably, with spinel structure) containing some Si and Nb and even minor amounts of La and Al.
